CONTAMINANTS VS MICROMETEORITES FROM THE

1965 LEONID METEOR SHOWER

M. B. Blanchard, N. H. Farlow, and G. V. Ferry

Ames Research Center, NASA

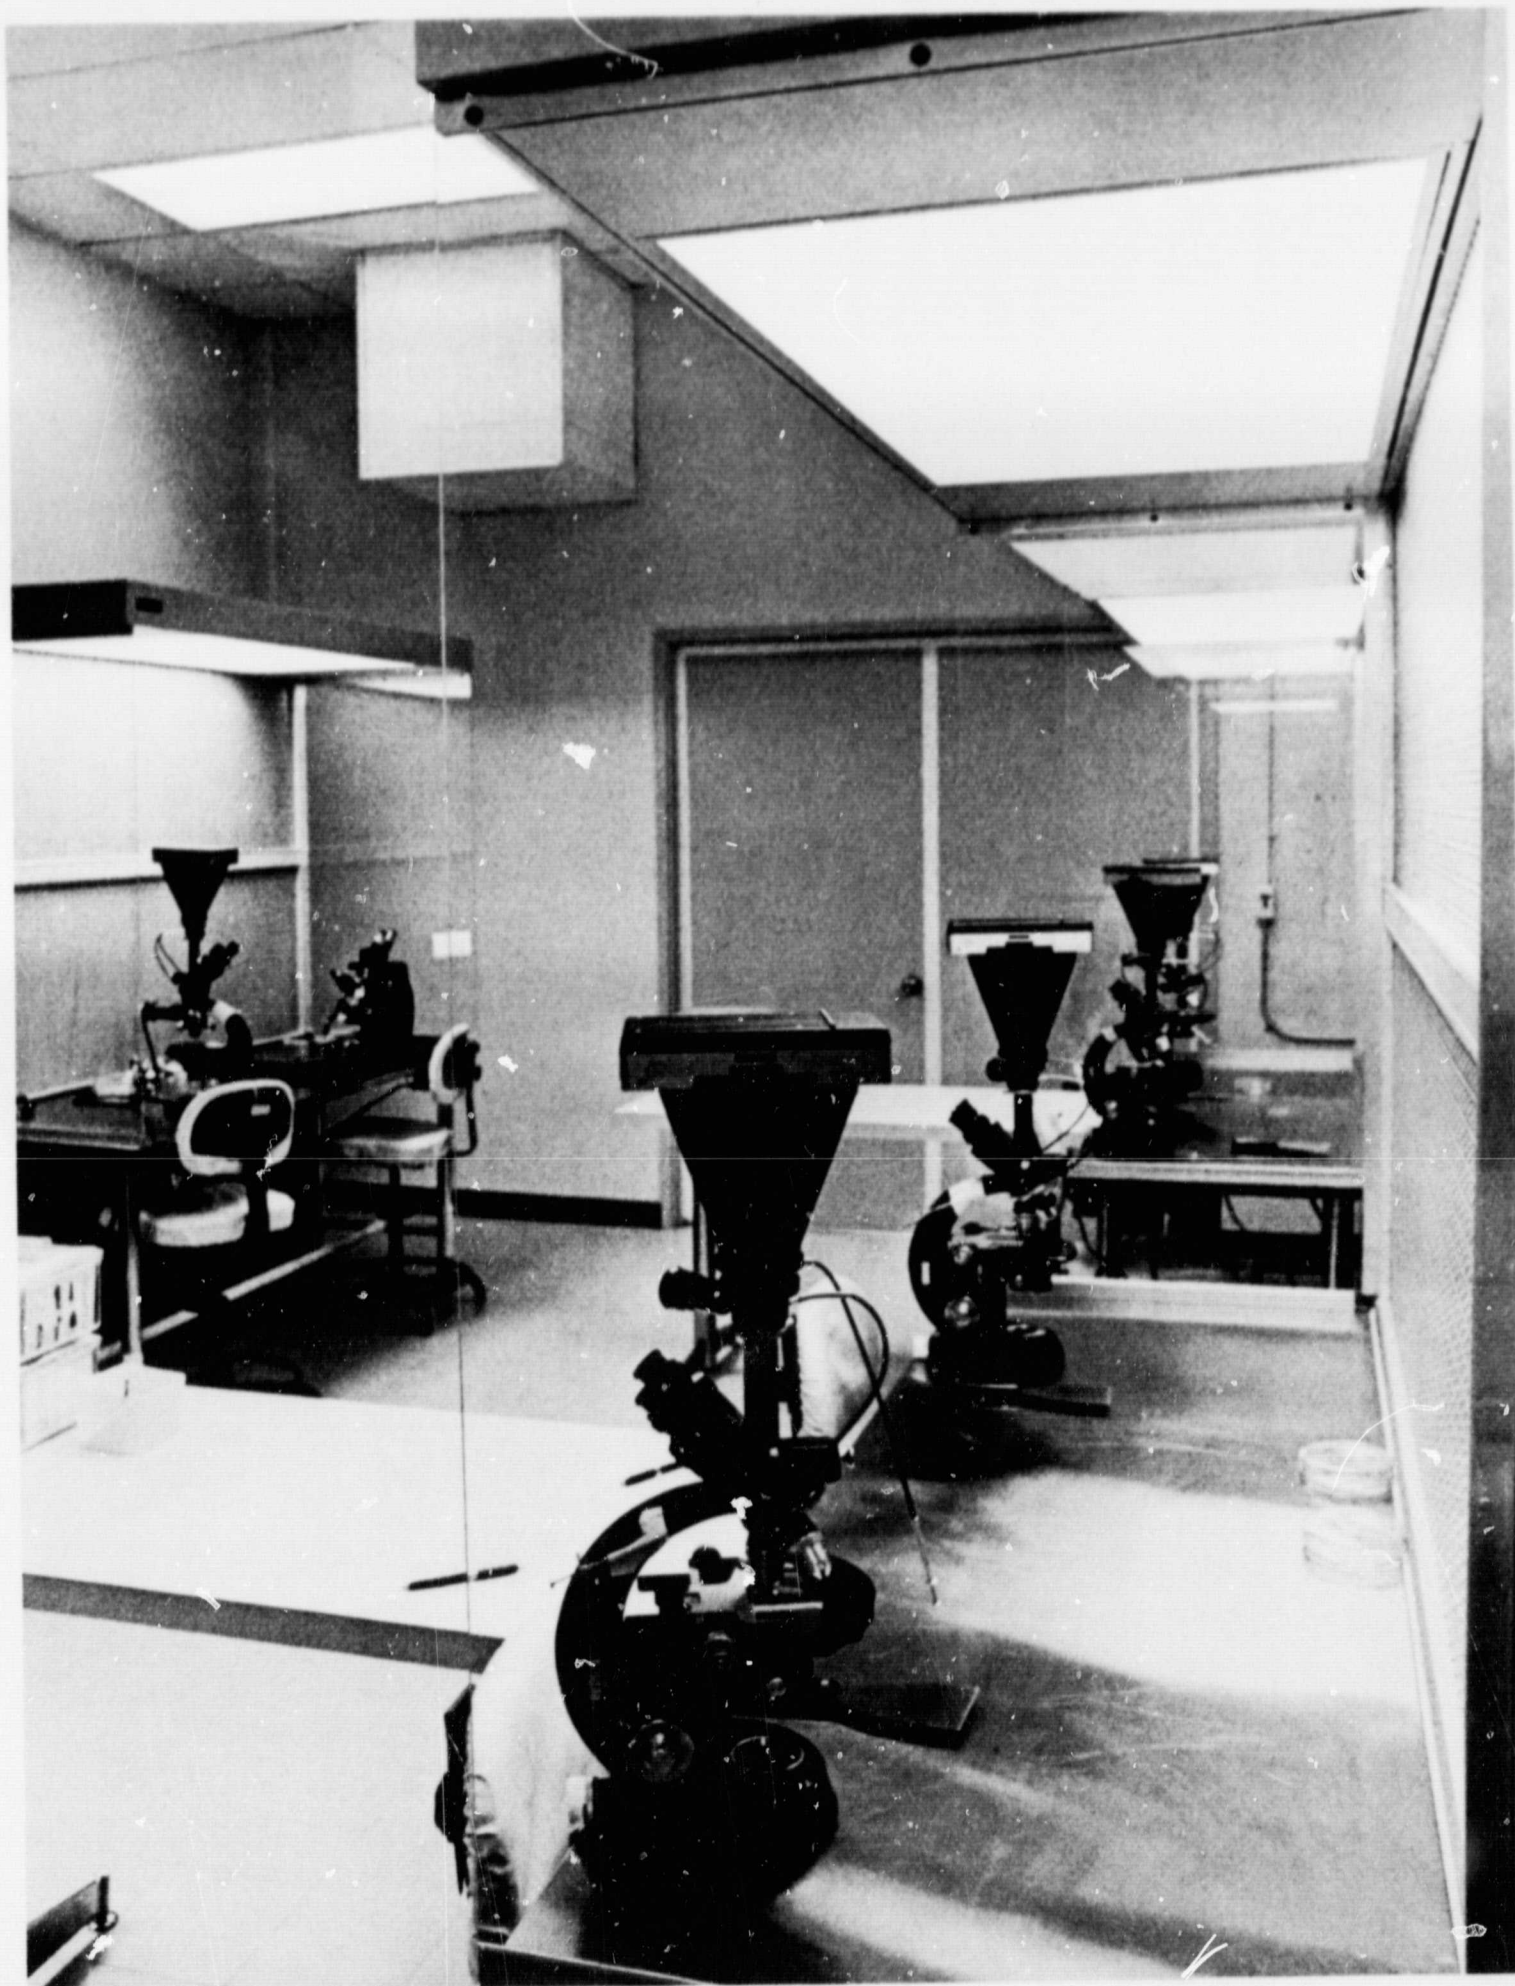
Figure 1

The optical survey was conducted using microscopes located inside laminar flow work benches which were inside a clean room meeting Fed Std 209, Class 100 (see figure 1). The slides and filters, containing particles from the dissolved vinyl films, were stored in pre-cleaned petri dishes inside a separate laminar flow work bench (see figure 2) used only for storage. In order to perform an optical survey on a slide, it was necessary to relocate a petri dish to the microscope. The slide was then removed with a spatula and placed directly onto the microscope stage. Therefore, during handling the slides were never touched except by the spatula. When a survey had been completed the slide was returned to the petri dish which was then relocated to the laminar flow storage bench.

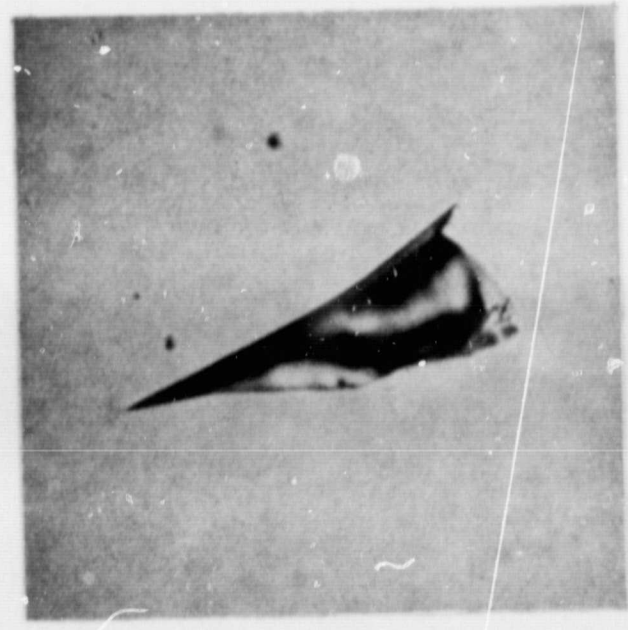
Figure 3

bright field, dark field, and polarized light were used. The entire surface of each non-flight slide was surveyed at 100x. Contaminants were counted, identified, and photomicrographed at 400x. Using these photomicrographs, a contaminant compendium was prepared based on morphology of the particles. Several variations of a given contaminant type were selected to complete the compendium. Identifications revealed the following to be principal contaminants: skin cells, acrylic plastic shreads, glass chips, metal chips and shreads, pieces of RTV (silicone rubber sealant), cloth fibers, and bacteria. These are illustrated in figure 3.

SKIN CELLS

BACTERIA

GLASS CHIP

METAL SHREAD

ACRYLIC PLASTIC

RTV

Identification of the contaminant types points to several contaminant sources. One was the flight payload. Using X-ray diffraction, one specimen was identified as a certain type of bronze. The source in the payload was a sintered bronze, oil impregnated, bushing located in an area remote from the modules. Another source was the modules themselves. Analyses using the electron microprobe identified a group of opaque particles found on flight slides to be shreads of metal plating. These metal shreads were generated by screws being threaded into tapped holes on the modules during installation on the flight instrument. But major sources were also found within the laboratory. Slide washing procedures appeared to be less effective than they should have been considering the specifications of the equipment being used. Laminar flow facilities were not excluding particles they were designed to eliminate. Clean garments were producing contaminants which should have been removed by proper laundering. Therefore, extensive tests were conducted to determine the limitations of the clean

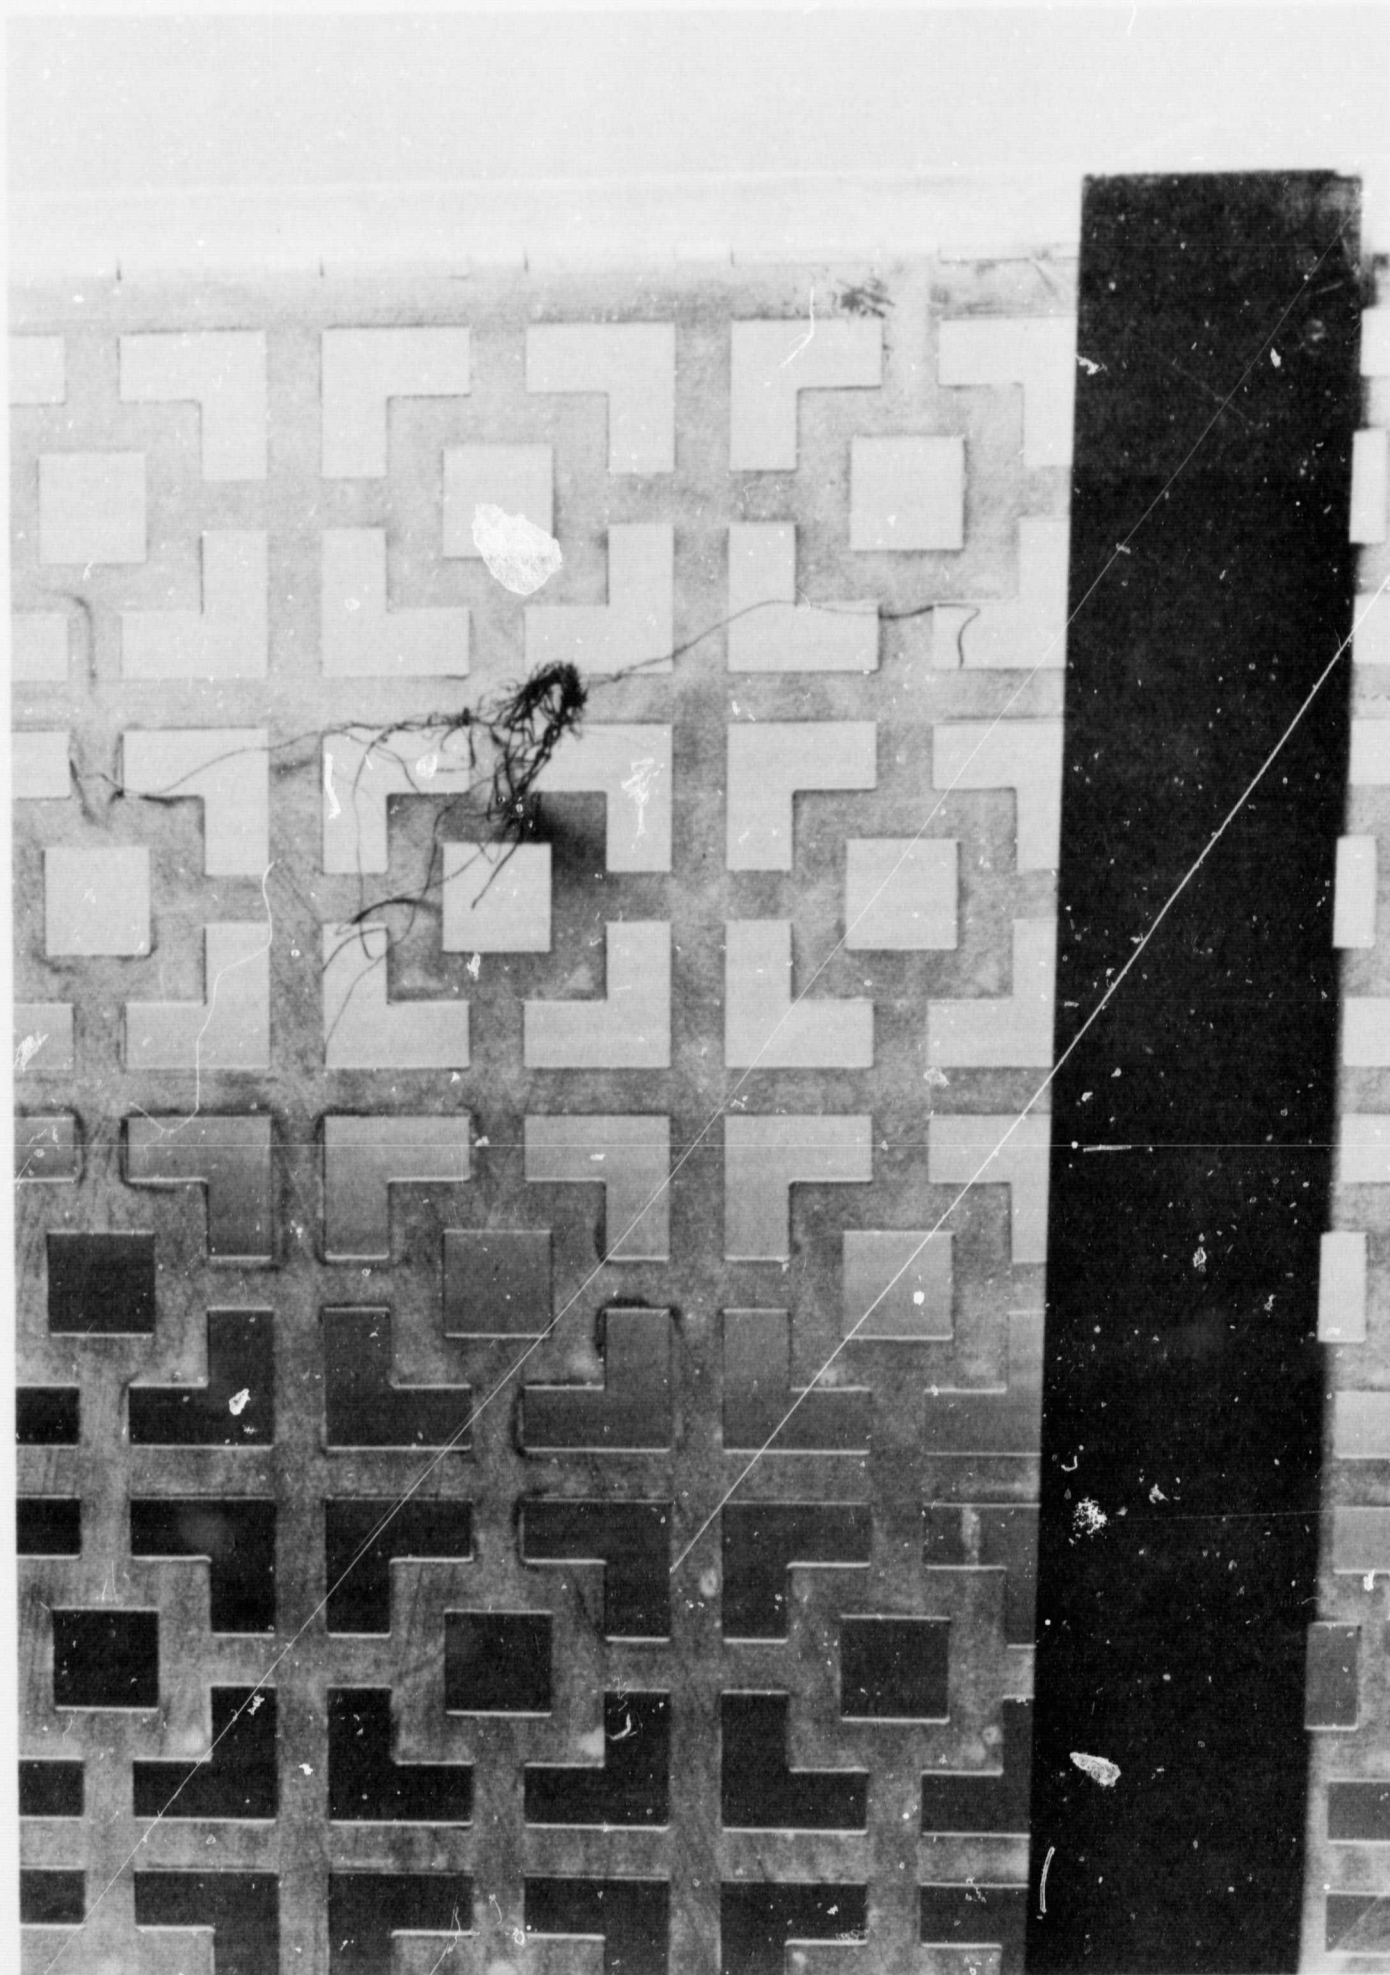
Figure 6

Prior to testing filters in the cabinets the protective grills had to be removed. The side of each grill facing the filter was found to be greasy and dirty (figure 6). Threads were observed to be working their way out of one filter. An assemblage of dirt particles were found deposited immediately in front of the filter on the frame (figure 7), and in one instance an unused screw hole demonstrated its contribution to particulate contaminants (figure 8). Each cabinet housing was characterized by many leaks at joints, seams, and electrical outlets. Discarding protective grills and sealing cabinet holes with clean vinyl tape corrected the problem. Polyethylene-covered fiber glass sound proofing located inside of the blower-motor chamber had torn loose and was abrading inside the blower squirrel cage on one cabinet. Removal of the sound proofing was performed, but some sources remained for glass particles to be transported directly into the plenum (figure 9).

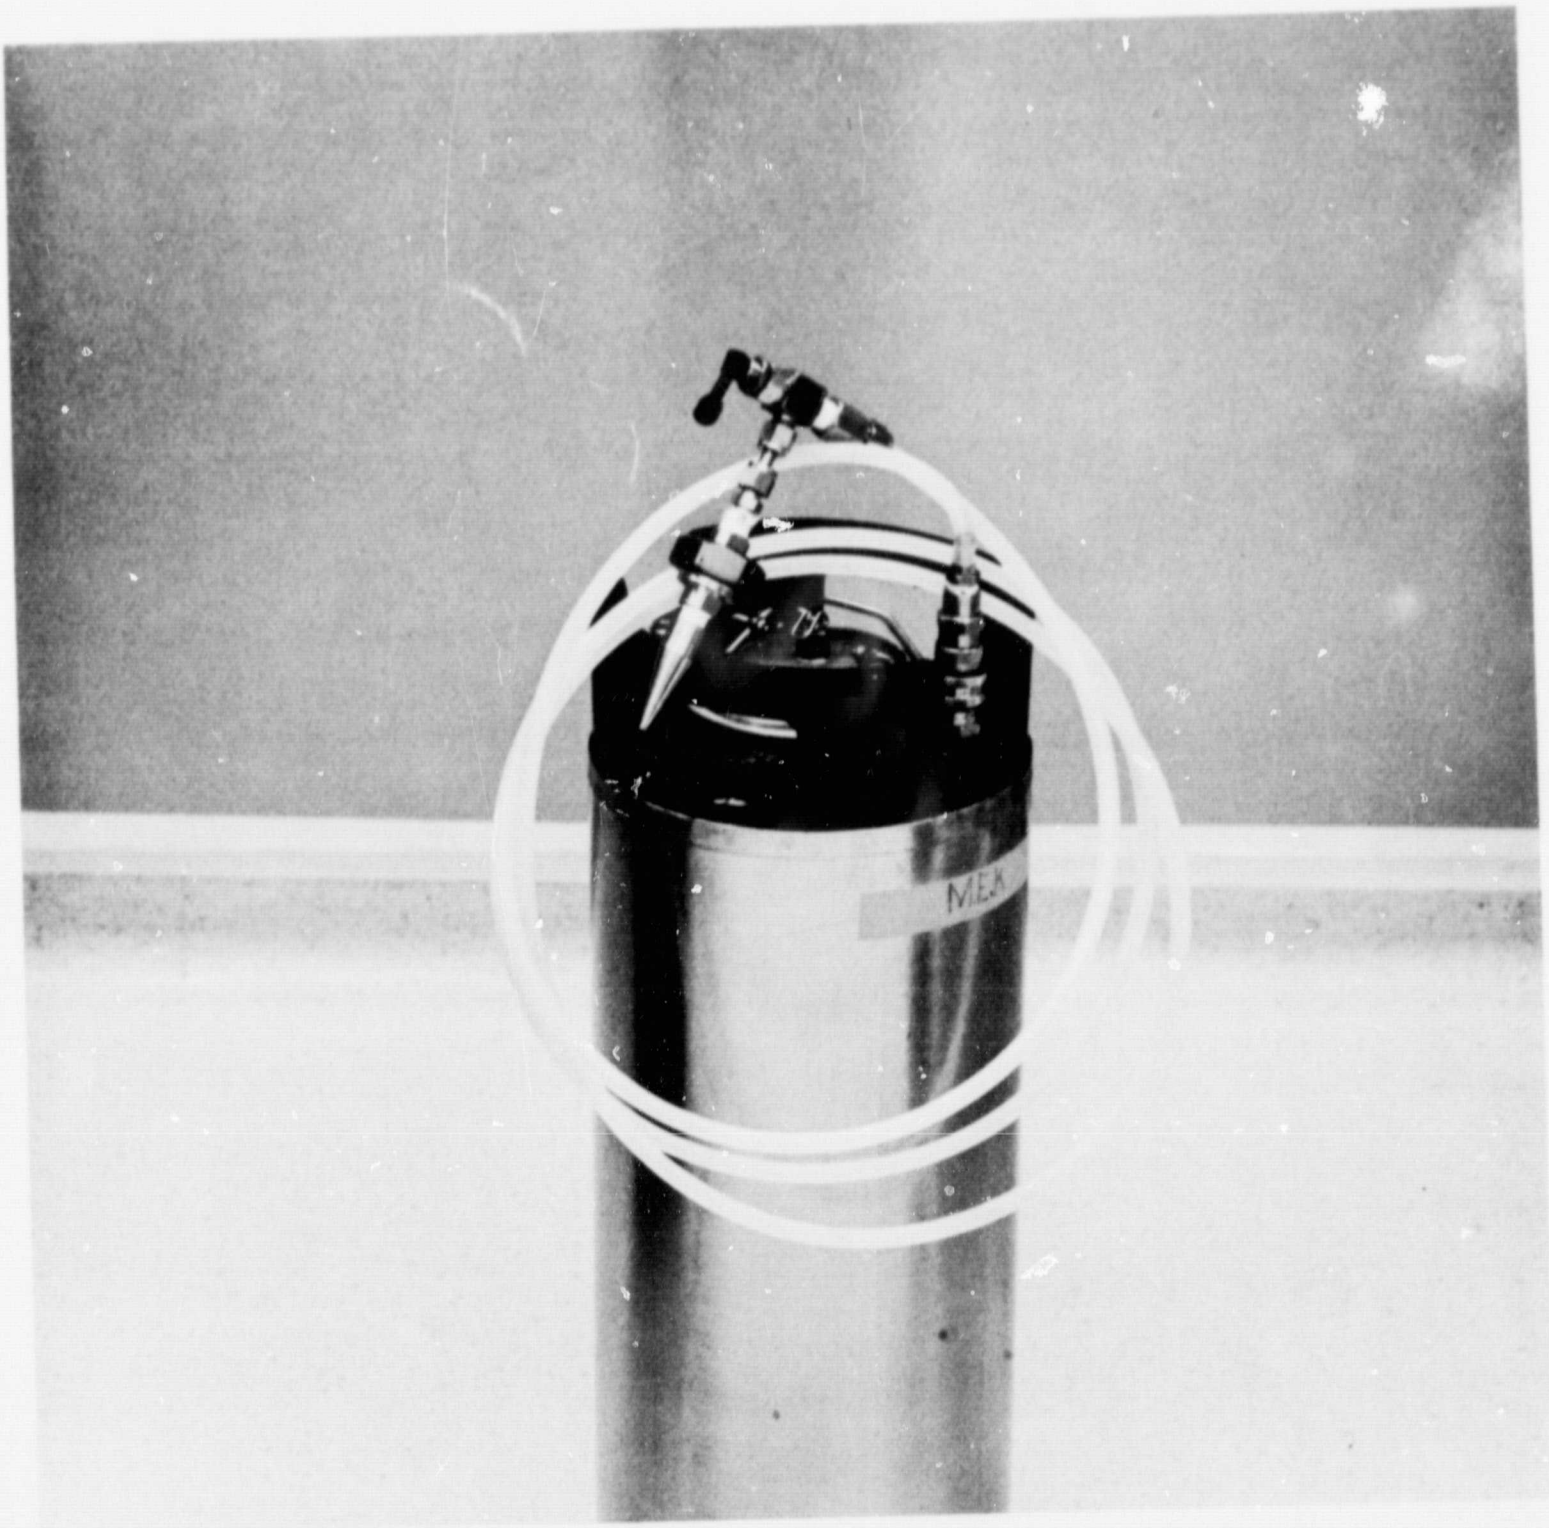
(top and bottom) with a nylon handle. Figure 18 illustrates the form of configuration "C" which has now been adopted for use at Ames in cleaning activities.
